Progress Report No. 33 for period ending January 31, 2007; Pond 2 Final Closure - Apex Site, Washington

County, Utah

Annual Site Inspection Summary Sheet - Apex Site - Pond 2

Surface Monument Survey Data Review - Apex Site

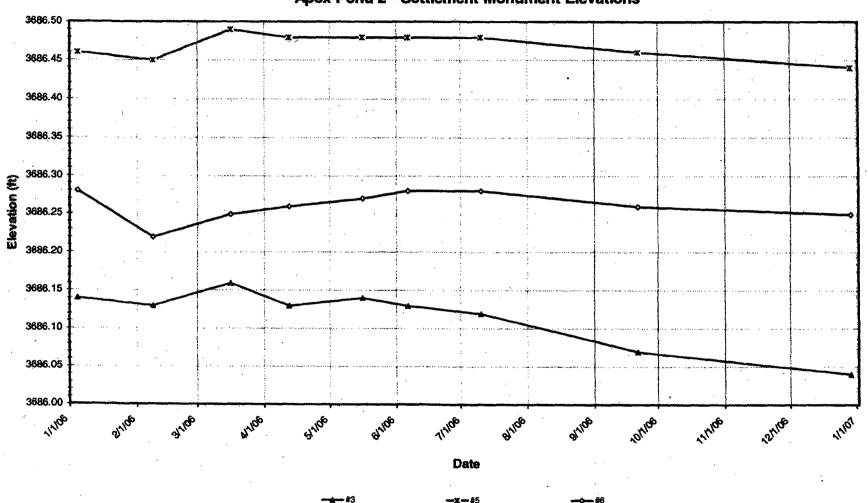
Apex Pond 2 - Settlement Monument Elevations

The settlement monuments were surveyed December 29 - no appreciable settlement has been noted. See attached September and December survey data, Alpha Engineering Company.

Based on data collected to date, MEI recommends that Hecla continue with their current plan and collect elevation data quarterly. Please call or email me if you have any questions concerning this review.
